**SITE CHARACTERIZATION WORK PLAN  
FOR  
THE RIVERBANK CITY DUMP  
(SWIS NO. 39-CR-0029)

SAN JOAQUIN COUNTY**

**SITE CHARACTERIZATION WORK PLAN  
FOR THE RIVERBANK CITY DUMP**

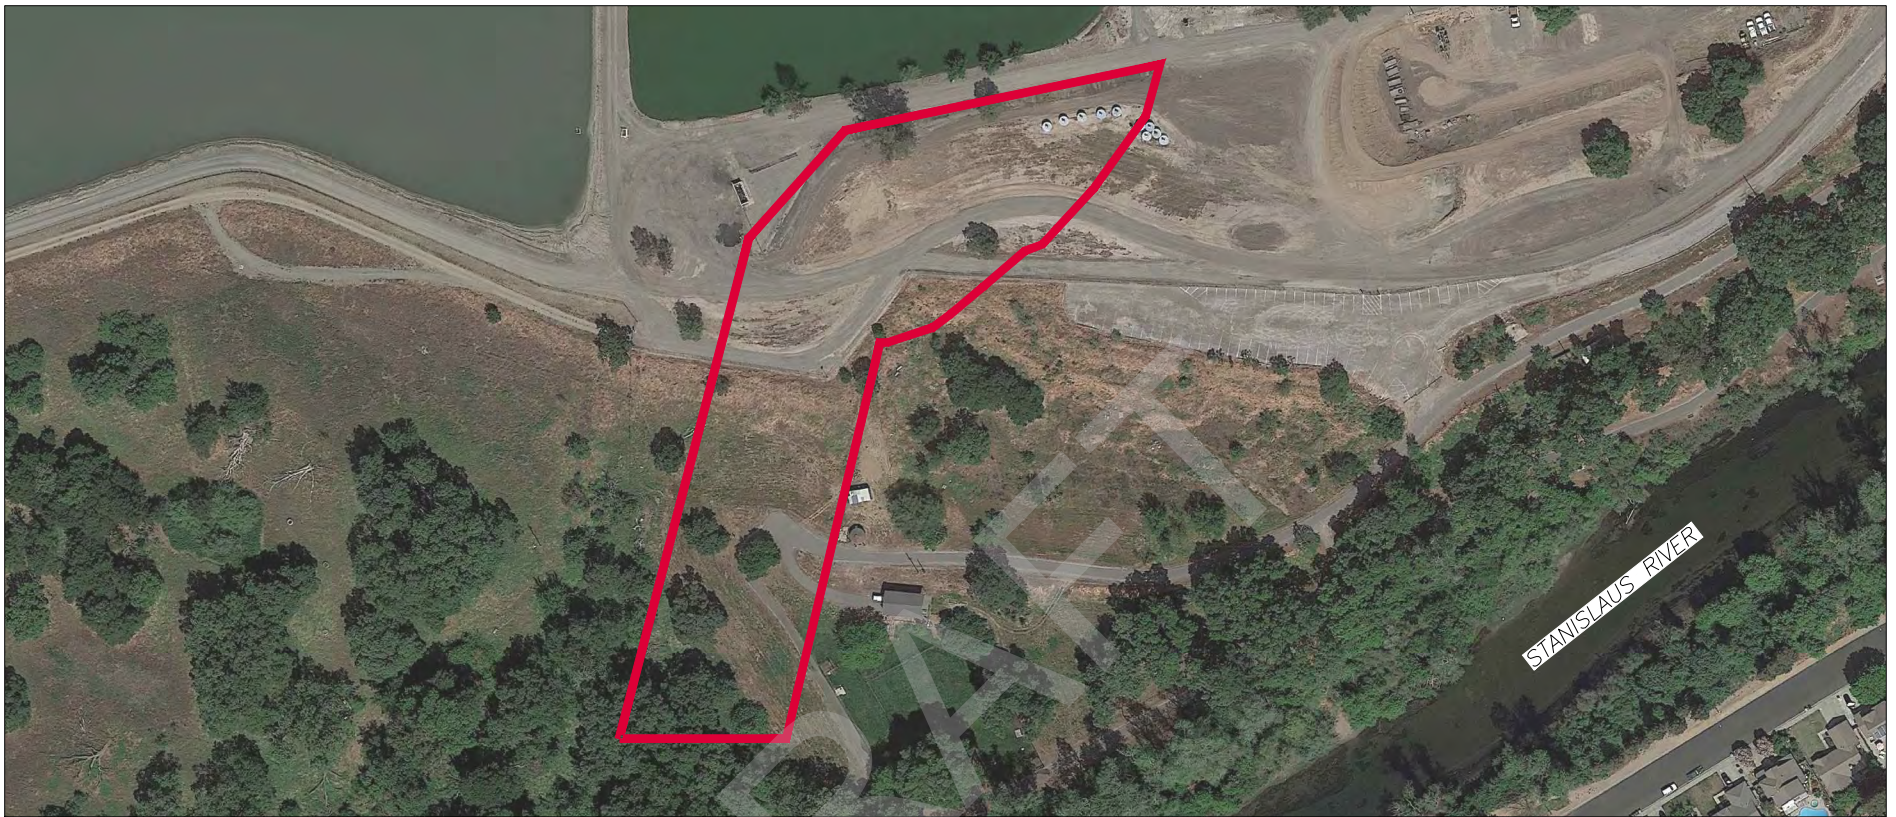
**FIGURE 2**

NOTE:  
POTENTIAL LIMITS OF WASTE FILL AREA BASED ON ANALYSIS OF HISTORICAL AERIAL PHOTOGRAPHS AND TOPOGRAPHIC MAPS.

**POTENTIAL WASTE LIMITS  
OF DISPOSAL SITE**

Preliminary assumptions concerning the nature, extent, and potential threat to public health and safety environment are that the Riverbank City Dump is shallow (probably <15 feet deep), has limited extent, and poses a very low potential threat to public health and safety and the environment. Figure 2 shows the approximate horizontal extent of the waste (i.e., waste limits) within the property boundary (approximately 0.76 acres). Assuming an average depth of 12 feet, the total estimated volume of waste in-place is approximately 14,800 cubic yards. The waste is likely to be mainly inert debris and land clearing materials (soil and vegetation) associated with WWTP construction activities, with “de minimis” degradable materials that could generate landfill gas or leachate. The LEA Site Identification Form (dated June 20, 2011, see Appendix A) ranked the threat posed by the Site as “C”, which is a low threat to public health and safety and the environment with minimal action needed to prevent human contact with waste. Current land use is non-irrigated open space and storage and staging activities associated with WWTP operations.

Based on the available information, potholes and/or trenches 10-15 feet deep are determined to be the most suitable intrusive field investigation method and are being proposed to determine the vertical and horizontal extents of waste fill. Because it is likely that large, resistant materials will be encountered, such as concrete slabs or asphalt, drilling or direct-push equipment are not suitable for the intrusive investigation. This intrusive field investigation (i.e., potholing and trenching) will be performed by sampling and analysis, and document the results of exploration on a topographic drawing for the disposal area which will depict the waste boundary, property lines, structures, and other investigation information. An initial magnetometer (metal detector) or ground penetrating radar (GPR) survey may be conducted to further define the area of potholing and trenching. The proposed excavation locations are shown on Figure 3 and will be marked prior to implementation. The location of pothole test pits and trenches, as shown on Figure 3, may be adjusted based on field conditions. The approximate limits of waste are shown on Figures 2 and 3.
