Reported Sight-Distance Obstruction at the Southwest Corner of Peltier and Bender Roads

APN 013-030-01 22353 Bender Road [Steve & Jacqueline West-property owners]

4/13/12

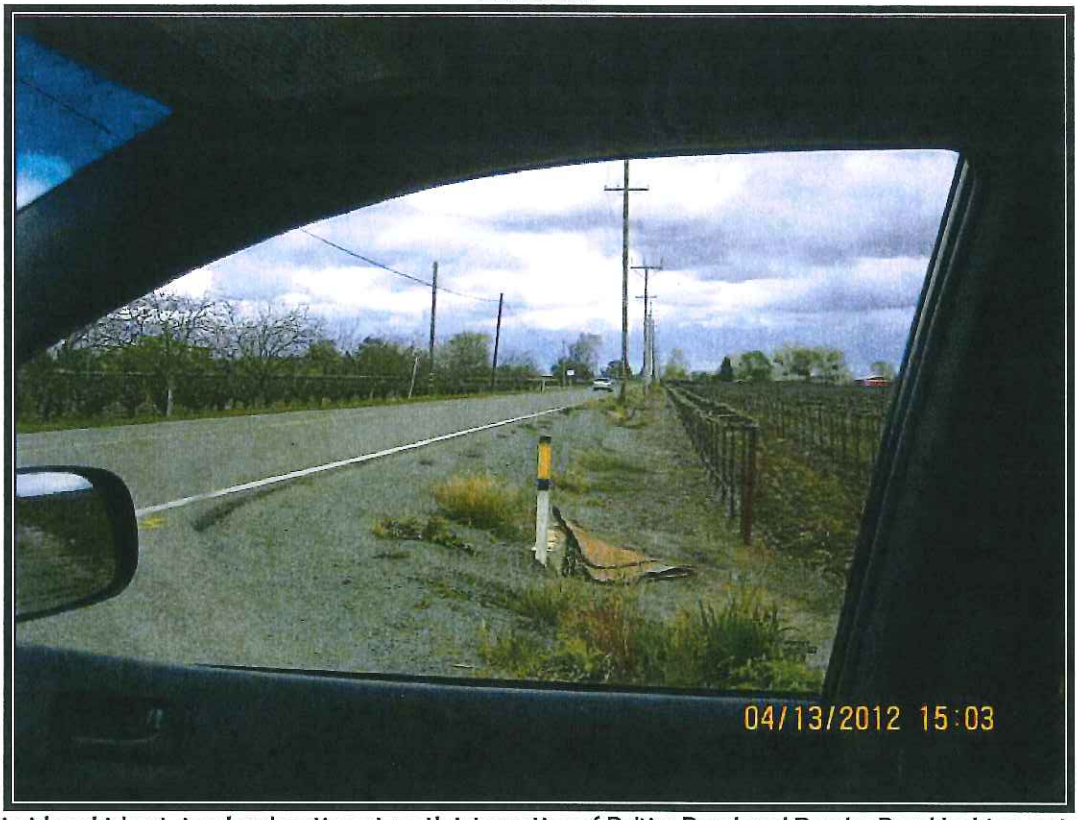
Photo taken from inside vehicle at stop bar location on Bender Road looking west along Peltier Road-Vehicle is approaching on the east-bound lane
